Manhole Inspection Summary

Manhole # S23S__002MH

Insp Date: **1/26/09 10:56 AM**

Location Address: **1769 Washington Blvd**

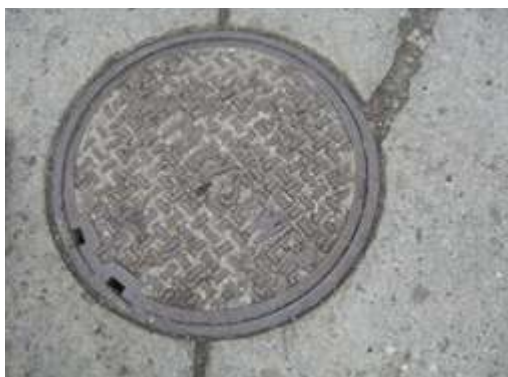
Miscellaneous

mh cover

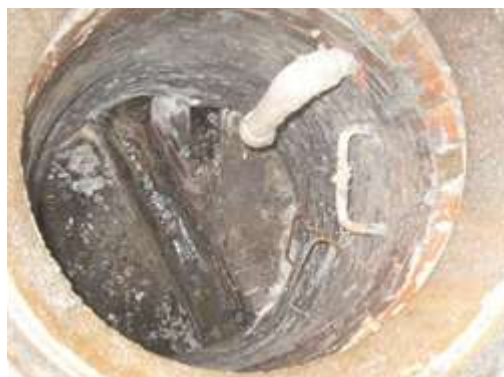
Miscellaneous

service line @ 9 O'clock

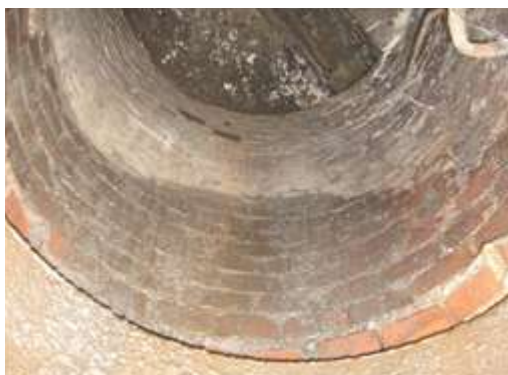
Defect 5

Infiltration: ☐ None ☐ Joint ☐ Cracks ☐ Mortar ☐ Roots ☒ **Wall**

infiltration along chimney and corbel walls

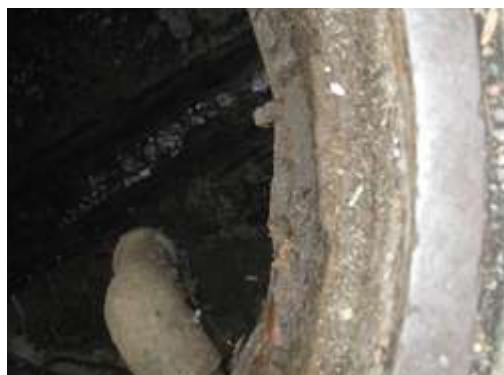
Defect 4

Frame Offset: **0.5** (in.) Condition: ☒ Sound ☐ Cracked ☐ Leaks

frame offset .5"

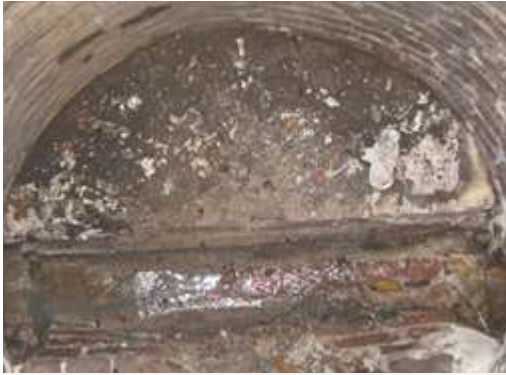
Defect 3

Condition: ☐ Sound ☐ Cracked ☐ Root Intrusion ☐ Deteriorated ☐ Leaks ☒ **Debris**

debris on bench

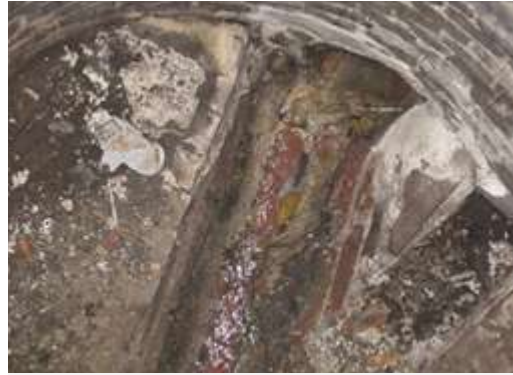
Defect 2

Condition: ☐ Sound ☐ Cracked ☐ Root Intrusion ☐ Deteriorated ☐ Leaks ☒ **Debris**

debris in channel

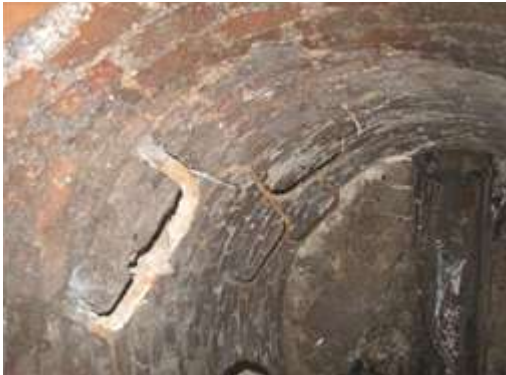
Defect 1

Steps Count: **4** Missing: **0** ☒ **Corroded**

corroded rungs

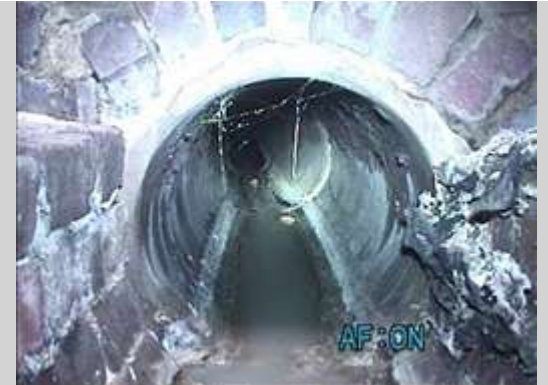
12 O'Clock Outflow

12 in. Circular Gravity Sewer
Pipe Out @ 12 O'Clock

Pipe Height: **12** (in.) Rod and Bar (Angled)
Pipe Material: **Clay** ☐ Pipe Lined
Invert Depth: **7.63** (ft.) Flow Characteristics: **Slow**
Deposits: ☒ None ☐ Mud ☐ Sludge ☐ Debris ☐ Grease
Silt Depth: **0** (in.) Deposits Extent:
Infiltration: **None** Pipe Seal Cond: **Sound**

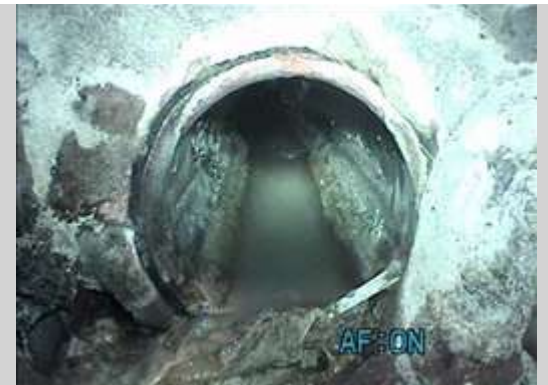
6 O'Clock Inflow

8 in. Circular Gravity Sewer
Pipe In @ 6 O'Clock

Pipe Height: **8.4** (in.) Rod and Bar (Angled)
Pipe Material: **Clay** ☐ Pipe Lined
Invert Depth: **7.47** (ft.) Flow Characteristics: **Slow**
Deposits: ☒ None ☐ Mud ☐ Sludge ☐ Debris ☐ Grease
Silt Depth: **0** (in.) Deposits Extent:
Infiltration: **None** Pipe Seal Cond: **Sound**

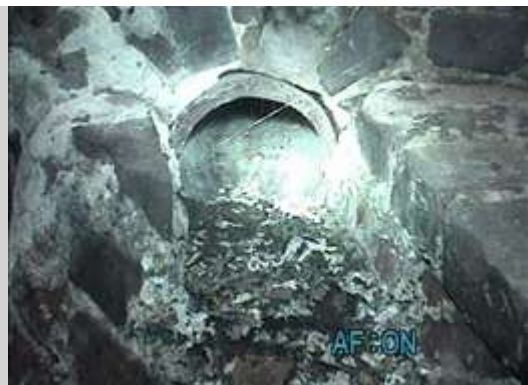
7 O'Clock Inflow

6 in. Circular Gravity Sewer
Pipe In @ 7 O'Clock

Infiltration: **None** Pipe Seal Cond: **Unknown**

Connects To: **Stub connection / abandoned**
